A STUDY OF
FACTORS AFFECTING ABRASION RESISTANCE
OF CONCRETE SURFACES

A STUDY MADE BY THE
CALIFORNIA DIVISION OF HIGHWAYS
IN COOPERATION WITH THE
U.S. DEPT. OF COMMERCE
BUREAU OF PUBLIC ROADS

NOVEMBER 1965

Lab Project Work Order 250908 HPR-1(2) D0307

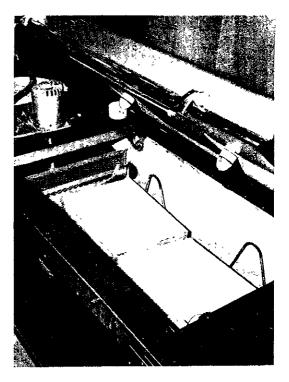
12 Blocks being frozen during early curing period

Three of the test blocks received a freezing treatment intended to simulate unexpected freezing conditions which might occur during construction. After approximately 24 hours of moist curing, the block was placed in a freezer and exposed to air at 15°F for 8 hours a day on 3 consecutive days. Blocks were covered with wet mats when not in the freezer. Thermocouples placed in the concrete indicated minimum temperatures of 24° at a 1-inch depth and 27° at 2 inches. At 4 days of age, the concrete blocks were stripped from the molds and placed in the moist curing room. They remained there for 3 days before being removed and stored in laboratory air.

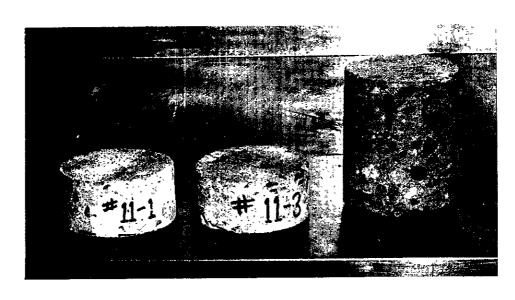
Specimens before and after sawing to 2-inch test height

Since the abrasion specimens were to be 2 inches high, the bottom 3 inches of each core was cut off and discarded. The

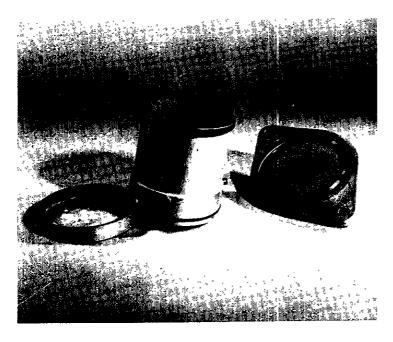
17 Container for abrasion test

Since it was felt that an impact type test might be more satisfactory for evaluating abrasion resistance, a test method of this type was devised. This was done by modifying an existing test which had been developed for determining the surface abrasion of a compacted bituminous mixture (8). The complete procedure, as adopted and used in this project, is described and illustrated at the end of this report. Briefly, the test consists of placing a 4-inch diameter by 2-inch high specimen in a 5-inch high container, adding steel balls and water, and shaking for three minutes on a mechanical shaker. (See photographs.)

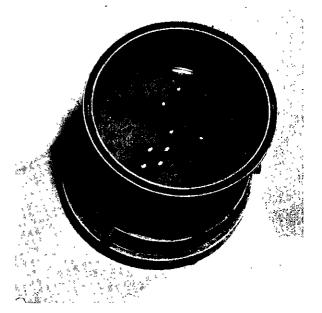
Specimen in place for abrasion test
